Manhole Inspection Summary

Manhole # S49AA_042MH

Insp Date: **9/23/08 8:41 AM**

Location Address: **2709 e monument st**

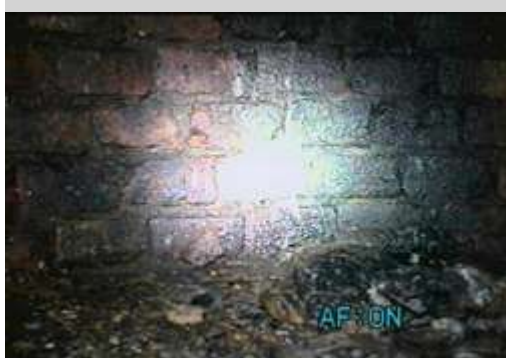
Defect 2

Condition: ☐ Sound ☐ Cracked ☐ Root Intrusion ☐ Deteriorated ☐ Leaks ☒ **Debris**

bench debris

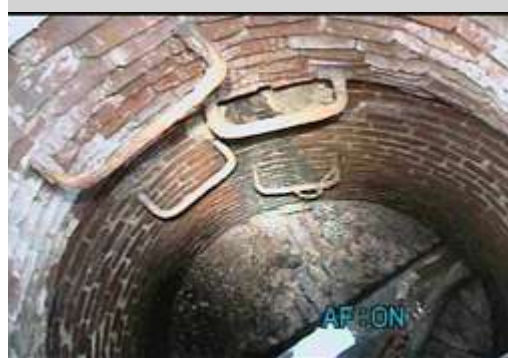
Defect 1

Condition: ☐ Sound ☐ Cracked ☐ Root Intrusion ☐ Loose Brick ☒ **Deteriorated**

Count: **4** Missing: **0** ☒ **Corroded**

corr steps and corbel

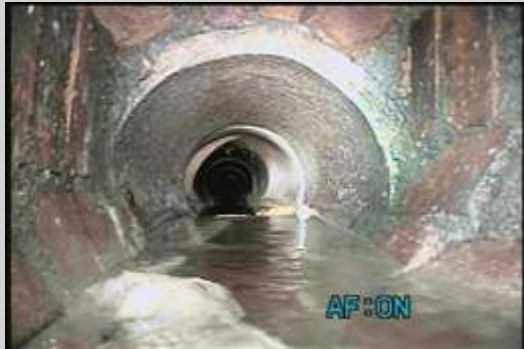
12 O'Clock Outflow

8 in. Circular Gravity Sewer
Pipe Out @ 12 O'Clock

Invert Depth: **8.83** (ft.) Flow Characteristics: **Fast**

Deposits: ☒ None ☐ Mud ☐ Sludge ☐ Debris ☐ Grease

Infiltration: **None** Pipe Seal Cond: **Unknown**

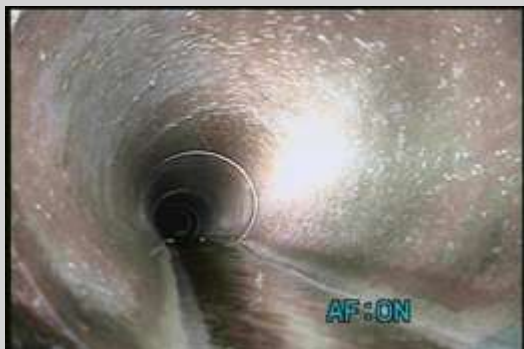
3 O'Clock Inflow

8 in. Circular Gravity Sewer
Pipe In @ 3 O'Clock

Invert Depth: **8.50** (ft.) Flow Characteristics: **Fast**

Deposits: ☒ None ☐ Mud ☐ Sludge ☐ Debris ☐ Grease

Infiltration: **None** Pipe Seal Cond: **Unknown**

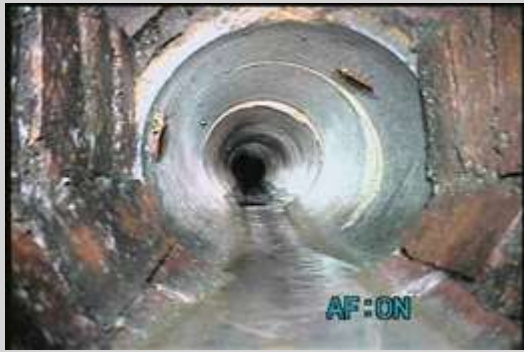
6 O'Clock Inflow

8 in. Circular Gravity Sewer

Pipe In @ 6 O'Clock

Invert Depth: **8.75** (ft.) Flow Characteristics: **Slow**

Deposits: ☒ None ☐ Mud ☐ Sludge ☐ Debris ☐ Grease

Infiltration: **None** Pipe Seal Cond: **Unknown**

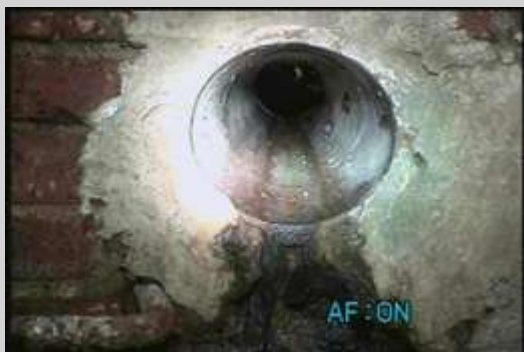
9 O'Clock Inflow

6 in. Circular Gravity Sewer

Pipe In @ 9 O'Clock

Invert Depth: **4.83** (ft.) Flow Characteristics: **None**

Deposits: ☒ None ☐ Mud ☐ Sludge ☐ Debris ☐ Grease

Infiltration: **None** Pipe Seal Cond: **Unknown**

Connects To: **House connection / Service line**
